# **Restoring Fatigue Performance Of Corrosion Damaged Aa7075-T6 and Fretting in 4340 Steel with Low Plasticity Burnishing**

Paul S. Prevéy  
Lambda Research

John T. Cammett  
NAVAIR

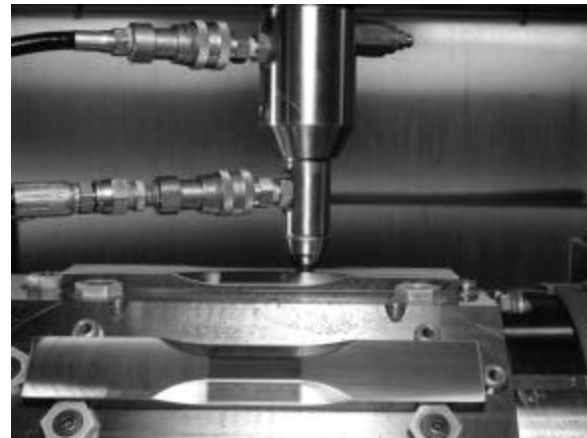
**Figure 1** – LPB processing of fatigue samples with at single point contact LPB tool in a 4-axis CNC mill.

Using CNC positioning, the tool path is controlled so that the surface is covered with a series of passes at a separation maintained to achieve maximum compression with minimum cold working. The tool may be moved in any direction along the surface of a complex work piece, as in a typical multi-axis CNC machining operation. The LPB processing of fatigue

specimens used in this investigation is depicted in Figure 1.

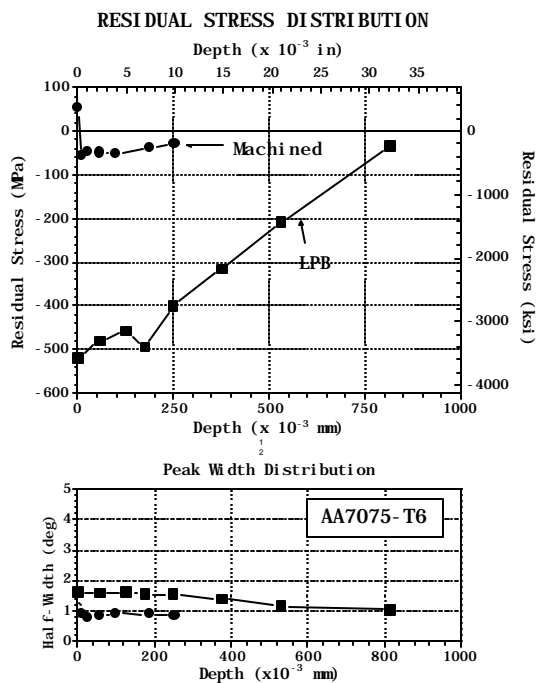
**Figure 2** - Residual stress and half width distribution in machined and LPB processed AA7075-T6.

The residual stress distributions developed by machining and LPB processing of 7075-T6 are shown in Figure 2. Machining of 7075-T6 produced low tension on the surface and compression of less than -68 MPa (-10 ksi) below the surface. In contrast, LPB produced maximum compression on the order of -480 MPa (-70 ksi) between the surface and a depth of nominally 0.2 mm (0.008 in.). Maximum cold work occurs from the surface through the region of maximum compression, and then diminishes with depth. X-ray diffraction measurement could not be made reliably below a depth of 0.5 mm (0.02 in.) in the 7075-T6 because of the coarse grain size encountered at depths beneath the deformed surface layer.

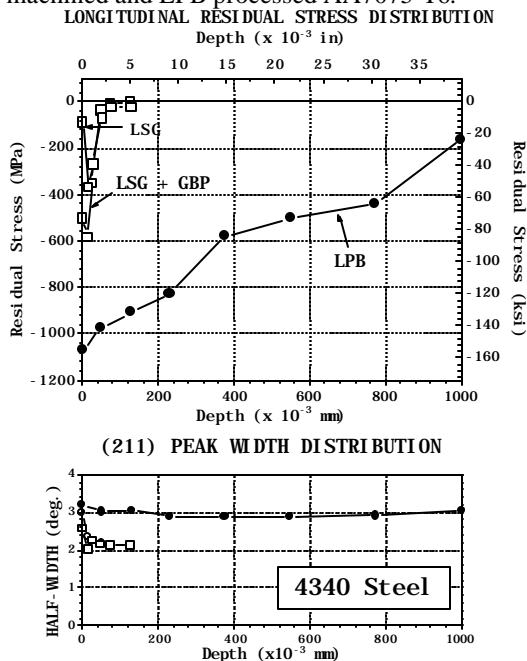
**Figure 3** - Residual stress and diffraction peak half-width distributions of low stress ground (LSG), glass bead peened (GBP) and low plasticity burnished (LPB) 4340 steel.

Residual stress and cold work distributions produced by grinding and LPB of 4340 steel are shown in Figure 3. Low stress grinding alone left the surface slightly compressive, with a subsurface peak compression on nominally -350 MPa (-50.8 ksi). Grinding and glass bead peening (GBP) of 4340 steel produced surface compression on the order of -500 MPa (-72.6 ksi) and a compressive layer not exceeding a depth of 75 $\mu\text{m}$  (0.003 in.). LPB produced a compressive layer with a maximum of nominally -100 MPa (-14.5 ksi) at the surface and extending over 1 mm (0.04 in.) into the surface.

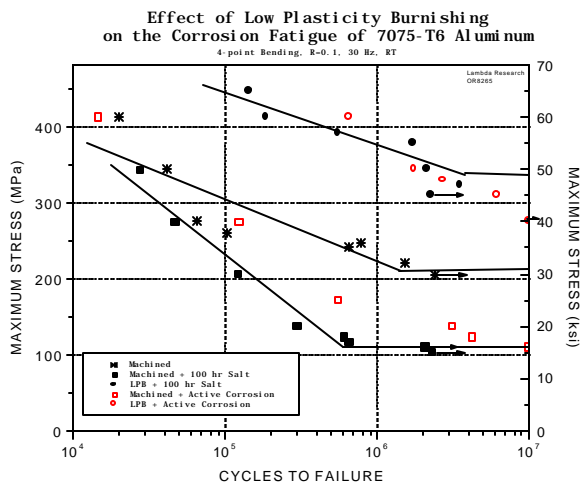
**Figure 4** - High cycle fatigue results for salt fog pitted and active corrosion fatigue of machined 7075-T6 with and without LPB processing prior to exposure to corrosion.

The S/N curves generated for 7075-T6 in both the baseline (as-machined) and LPB conditions, after 100 hr salt fog exposure or active corrosion fatigue, are presented in Figure 4. Fatigue tests were continued for a minimum of  $2.5 \times 10^6$  cycles with a maximum run-out at  $1.2 \times 10^7$  cycles. The fatigue data are presented as semi-logarithmic S/N curves in terms of the maximum stress.

The S/N curves for samples with pitting from prior salt fog exposure appeared to exhibit an endurance limit, implying infinite life below some threshold stress level. The S/N curves for samples exposed to active corrosion fatigue during testing do not appear to have an endurance limit, as is commonly observed in studies of corrosion fatigue.<sup>16</sup> In the discussion that follows, the results are considered and compared in terms of the fatigue life at nominally  $2 \times 10^6$  cycles.

The machined (end milled) surface condition produced an apparent endurance limit on the order of 200 MPa (30 ksi). Salt fog exposure for 100 hrs reduced the endurance limit to nominally 100 MPa (15 ksi), half that of the original machined surface

LPB prior to salt fog pitting resulted in a 70% increase in the endurance limit, from nominally 200 MPa (30 ksi) to over 330 MPa (48 ksi). LPB prior to corrosion increased the fatigue life at stress levels above the endurance limit 310 MPa (45 ksi) by two orders of magnitude, or one hundred times that of the baseline machined surface.

A comparable benefit in fatigue performance was observed for LPB prior to active corrosion fatigue in 3.5% NaCl solution. As noted earlier, a true endurance limit may not exist for the active corrosion fatigue mechanism; however, the fatigue strength at  $10^7$  cycles was at least 282MPa (41ksi). Fatigue lives were 100 times that of the baseline for stress levels above 275 MPa (40 ksi).

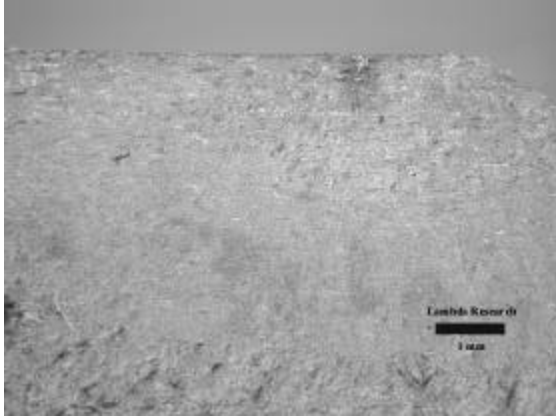
**Figure 5** – Typical surface fatigue initiation site on machined 7075-T6 in active corrosion fatigue.

Fractographic analysis revealed that all of the fatigue failures in specimens without prior LPB, whether exposed to salt fog pitting or active corrosion fatigue, initiated at the surface. A typical surface fatigue initiation site is shown in Figure 5. All of the salt fog pitted sample initiations were exclusively from corrosion pits, as observed previously<sup>6</sup>. Specimens tested at lower stresses generally exhibited origins from a single pit or surface location, while specimens tested at higher stress levels tended to have multiple nucleation sites.

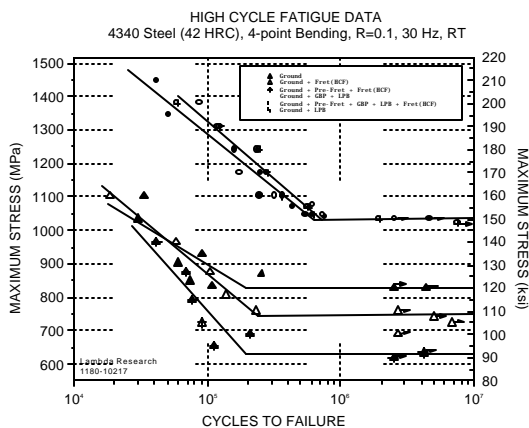
**Figure 6** – 4340 steel fretting fatigue results, as ground and with prior LPB treatment. Multiple fretting exposures simulate service damage, overhaul, and return to service.

The fretting fatigue results for 4340 steel are shown in Figure 6. The ground baseline samples produced an endurance limit of 827 MPa (120.0 ksi). Fretting of as-ground samples during fatigue testing reduced the endurance limit to nominally 758 MPa (110.0 ksi).

Pre-fretting followed by fretting during fatigue testing (simulating returning a fretted part to continued service) reduced the HCF endurance limit further to nominally 620 MPa (90.0 ksi), a loss of 25% of the initial fatigue strength.

LPB, either before or after fretting, produced an endurance limit of nominally 1033 MPa (150.0 ksi), 25% higher than ground 4340 without fretting damage. Even with fretting both before and after LPB, intended to simulate application of LPB of a component during overhaul followed by return to service, LPB gave the same 25% endurance limit increase, indicating complete mitigation of the fretting fatigue debit.

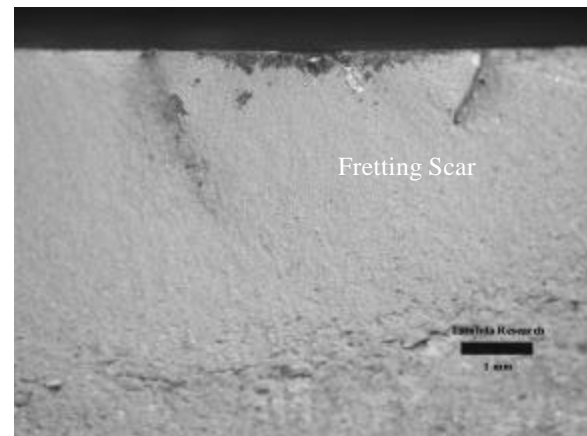
**Figure 7** – Fracture face of a 4340 steel fretting fatigue sample showing initiation from the edge of the fretting scar.

Fatigue initiated from the edge of the fretting scar in all of the 4340 samples without LPB. A typical fracture face, with the fretting scar visible at the top, is shown in Figure 7. Fatigue initiated in all of the LPB samples subsurface, just below the compressive layer, indicating a fatigue strength for the LPB surface higher than indicated by the results. The subsurface failures are interpreted as a limitation of the test technique and sample design which combined to allow the maximum tension to occur below the highly compressive test surface.
